accent American Inc

## Attic Area

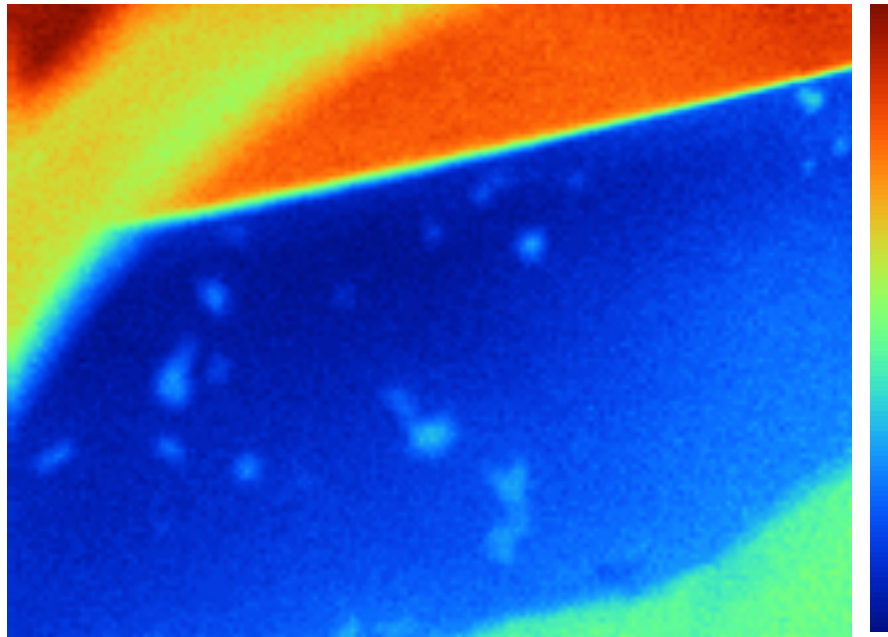
Property	Value
Created	01/07/2008 10:49:32
File name	2008-01-07-MON-10-49-32-001.pgm
Comment	The ceiling side facing the rafters has trapped moisture in it From the Hot water on the right side.

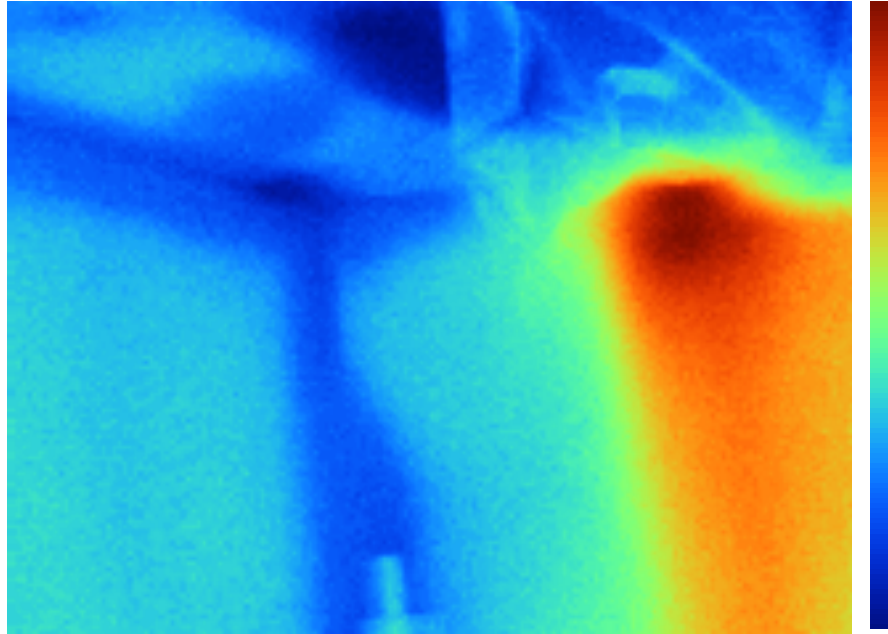
## Utility Rm Ceiling

Property	Value
Created	01/07/2008 10:50:38
File name	2008-01-07-MON-10-50-38-002.pgm
Comment	The water is migrating down through the ceiling and walls worknig itself down to the first floor.

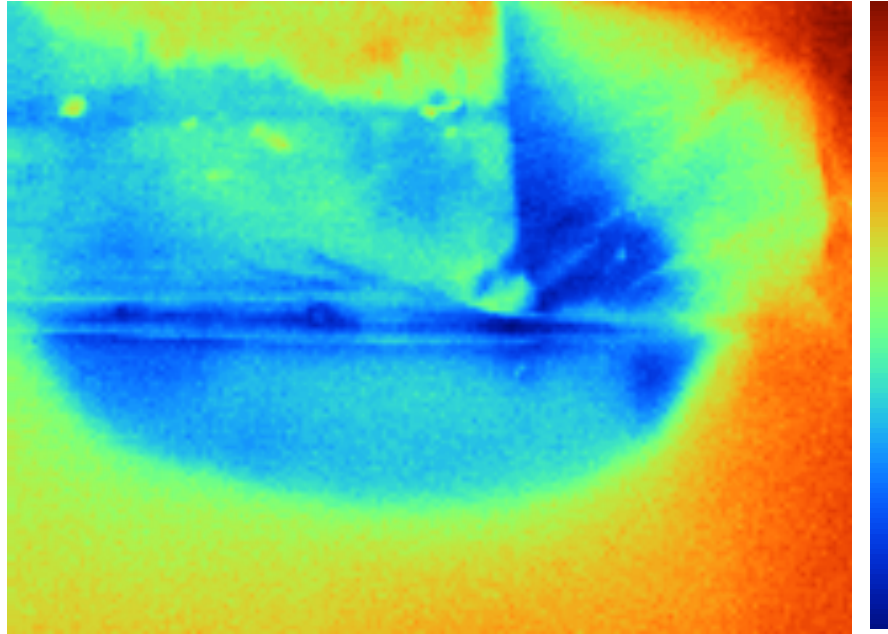
## Utility Ceiling right

Property	Value
Created	01/07/2008 10:52:05
File name	2008-01-07-MON-10-52-05-009.pgm
Comment	The right side of the temporary repair has wall and ceiling damage.

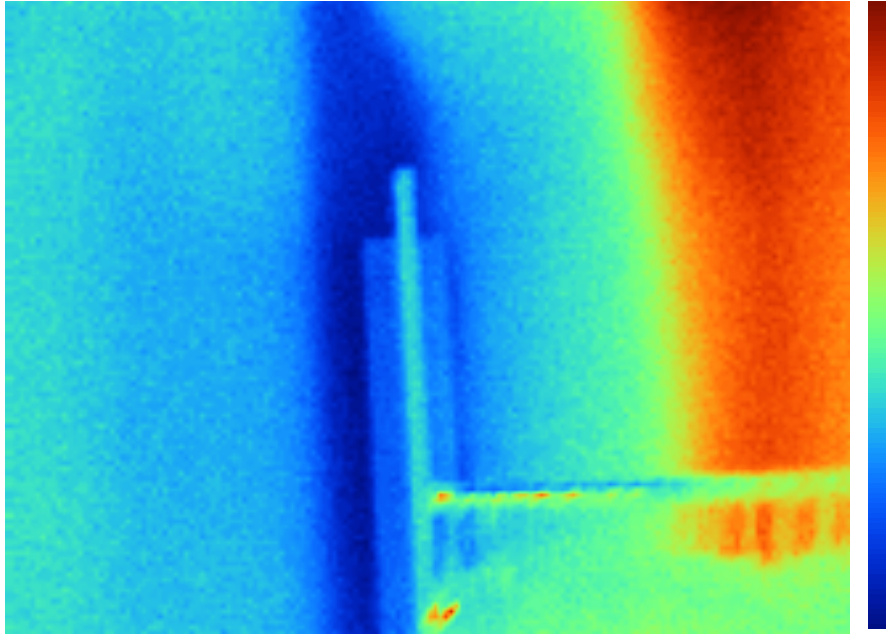
## Utility Rm Walls

Property	Value
Created	01/07/2008 10:50:41
File name	2008-01-07-MON-10-50-41-003.pgm
Comment	The water trapped in wall cavity traveling to floor.

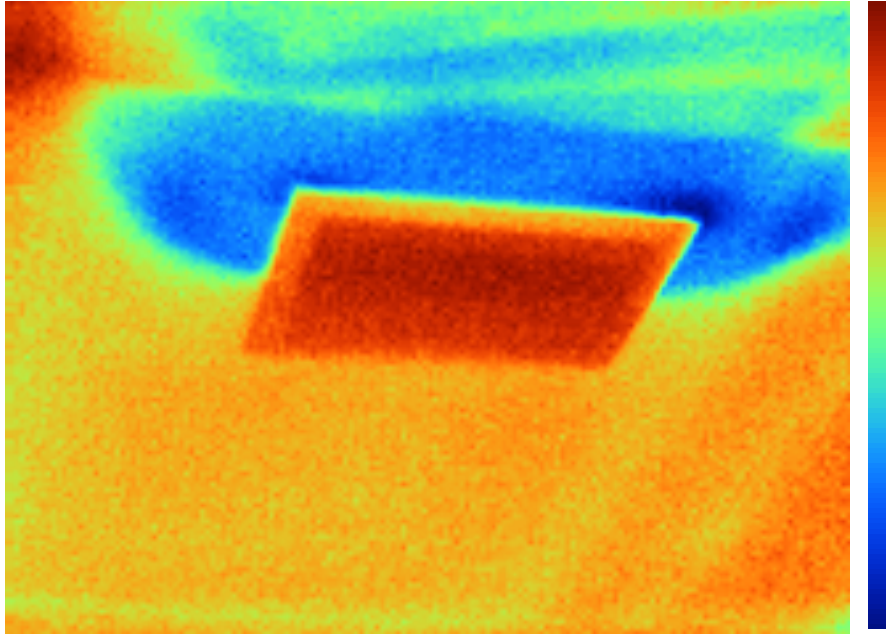
## Supply Vent

Property	Value
Created	01/07/2008 10:51:24
File name	2008-01-07-MON-10-51-24-008.pgm
Comment	The ceiling in the utility room where the supply vent is has a low spot where the water settled. It drained out but still needs to be dried. There is a slight bowing there. Drying may correct. The gap between the ceiling and the vent appears to be 1/16 of an inch.

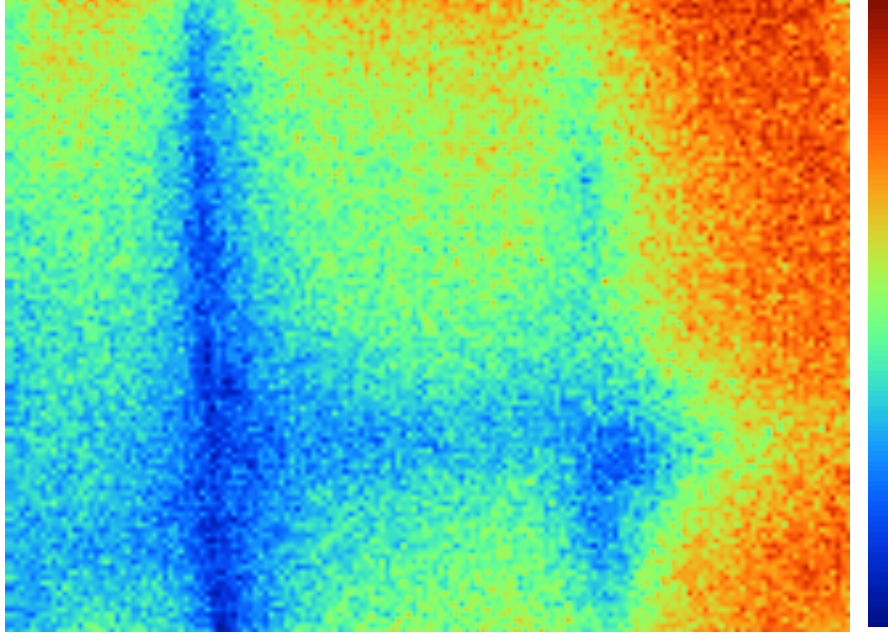
## Wall Studs

Property	Value
Created	01/07/2008 10:51:02
File name	2008-01-07-MON-10-51-02-006.pgm
Comment	There is moisture highly likely in some of the studs in the walls. We will drill holes in the walls where your carpenter removed baseboards and pump dry air inside to dry out.
